# Case Study Of The Marina Bay Suites & Other Residential Fires

# Marina Bay Suites Fire / Gaps

**Incident No** : /20140113/0915  
**Incident Date/Time** : 13 Jan 14 @ 21:34:58 hrs  
**Location** : Marina Bay Suites  
No. 3, Central Boulevard  
Singapore 018965.

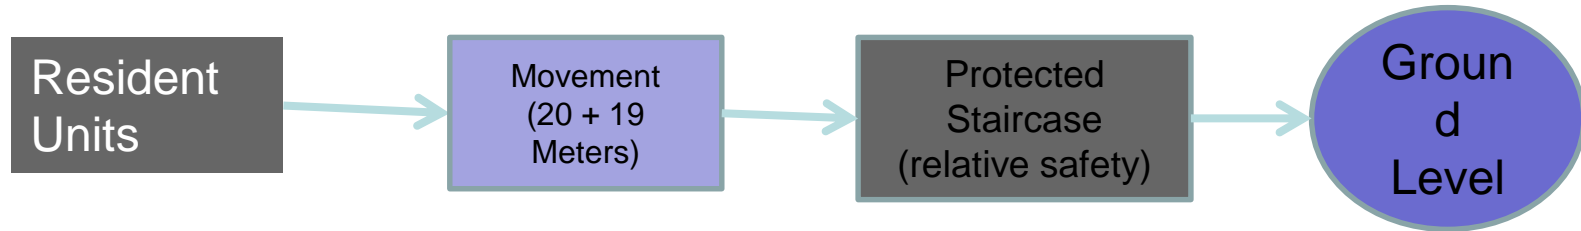
**Low-rise Building with Full Evacuation Mode**

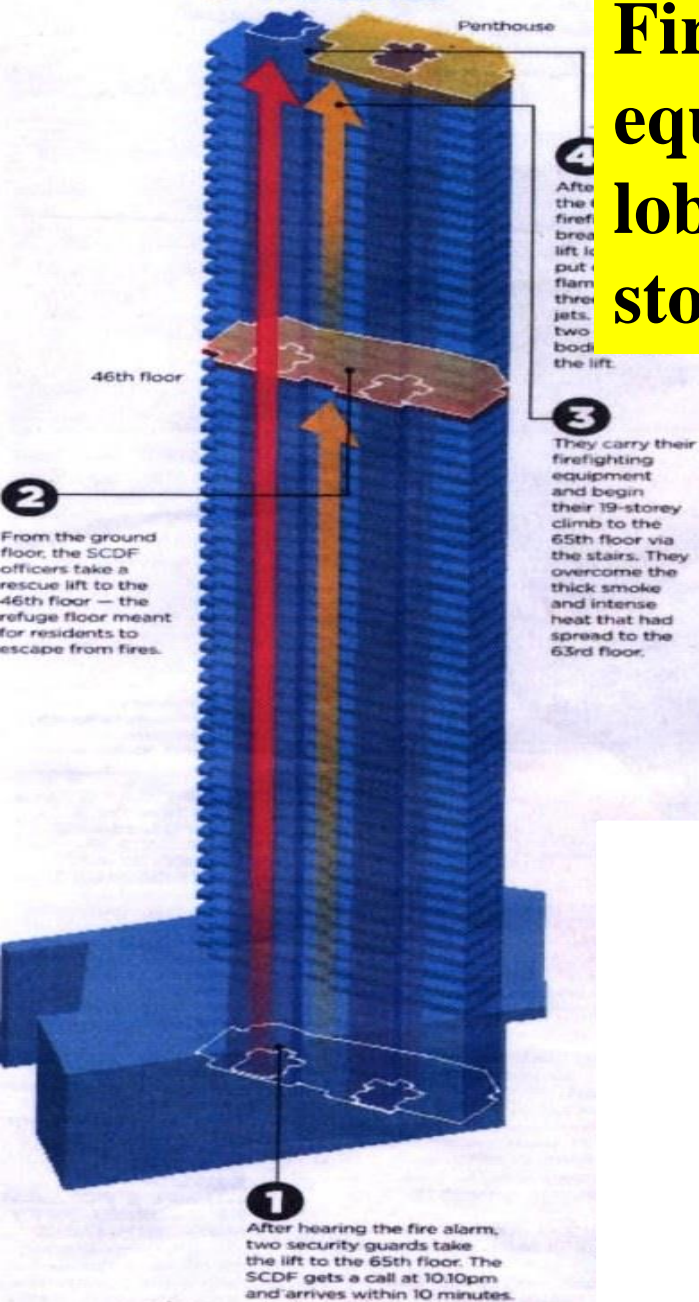
**Fire involved renovation materials and equipment placed at the fire fighting lobby, (Fireman Lift 3) at the 65<sup>th</sup> storey. 2 lives were lost in this fire.**

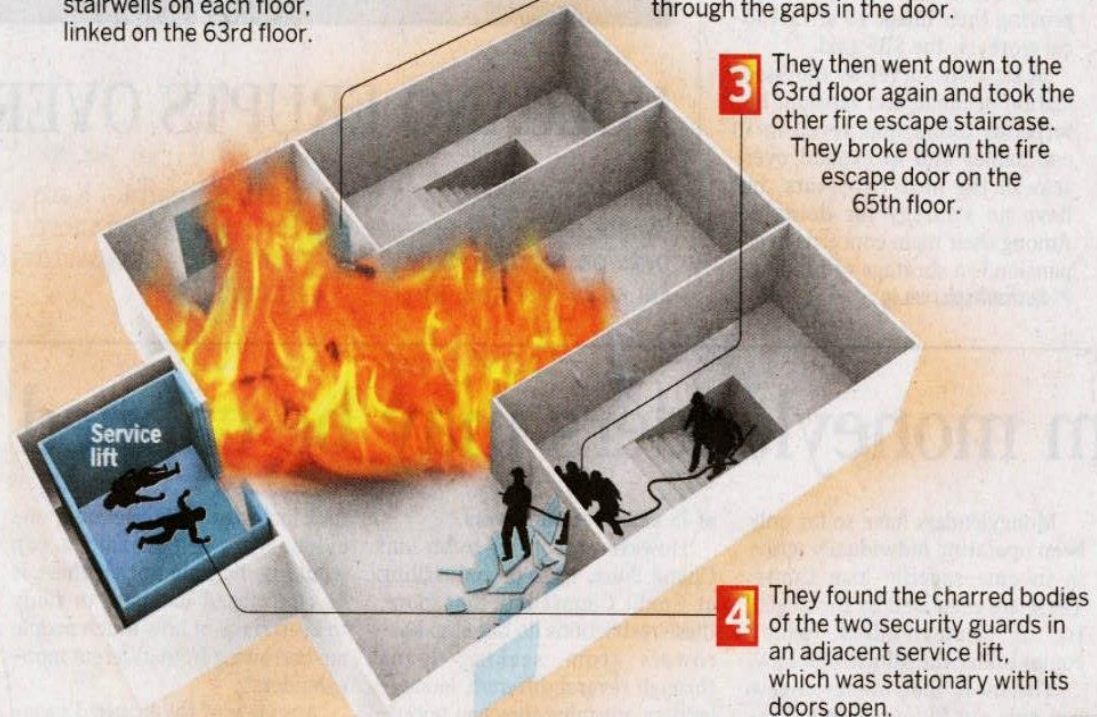
- 1** Singapore Civil Defence Force officers used the 63rd floor lobby as a point from which to carry out their fire fighting operations.
  - There were two fire escape stairwells on each floor, linked on the 63rd floor.
- 2** They got to the 65th floor but could not get past the door to the lobby as it was too hot to open.
  - Smoke was also entering the stairwell through the gaps in the door.

NOTE: Drawing not to scale.

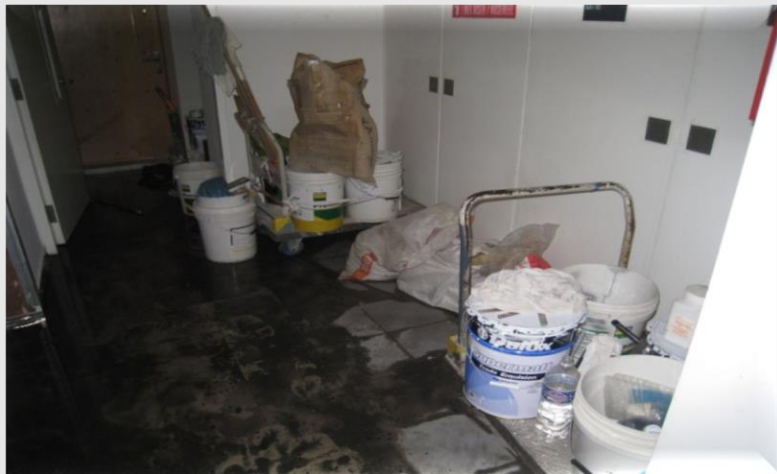
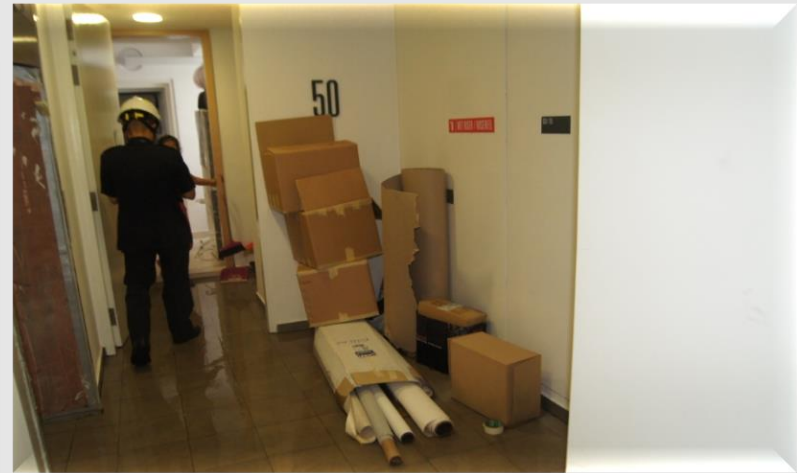
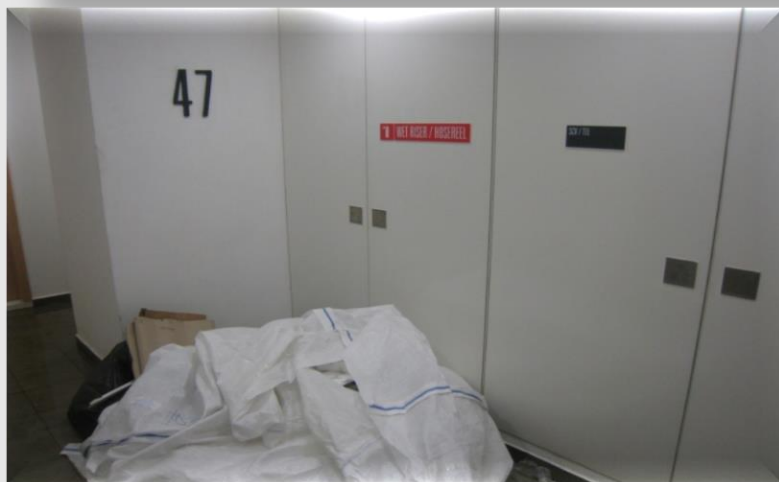
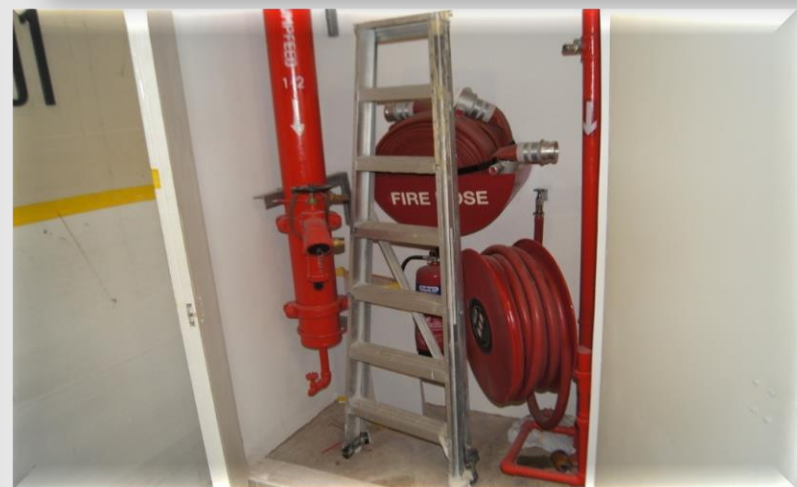
**FH Violations at storey 1, 47, 50, 62 & 65  
Involving the obstruction to fire protection systems and  
placement of combustibles along common passageways.**

- 1. Correct operations of fire lifts in the event of fire**
- 2. Management of common areas especially during renovation works**
- 3. Training and enhance fire safety knowledge of security guards / staff to handle fire emergencies**

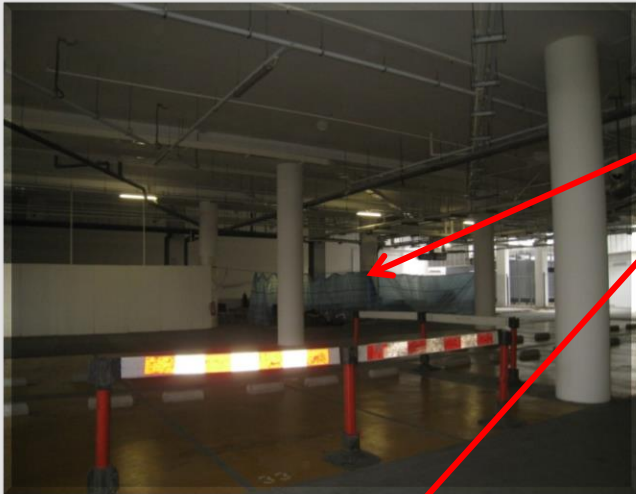
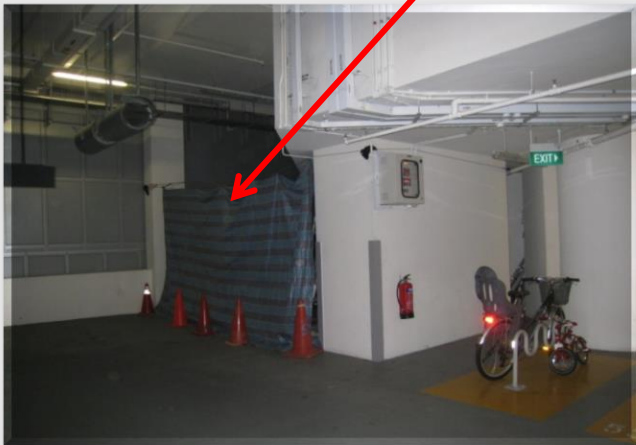
## FS Violations at 5<sup>th</sup> Storey Carpark

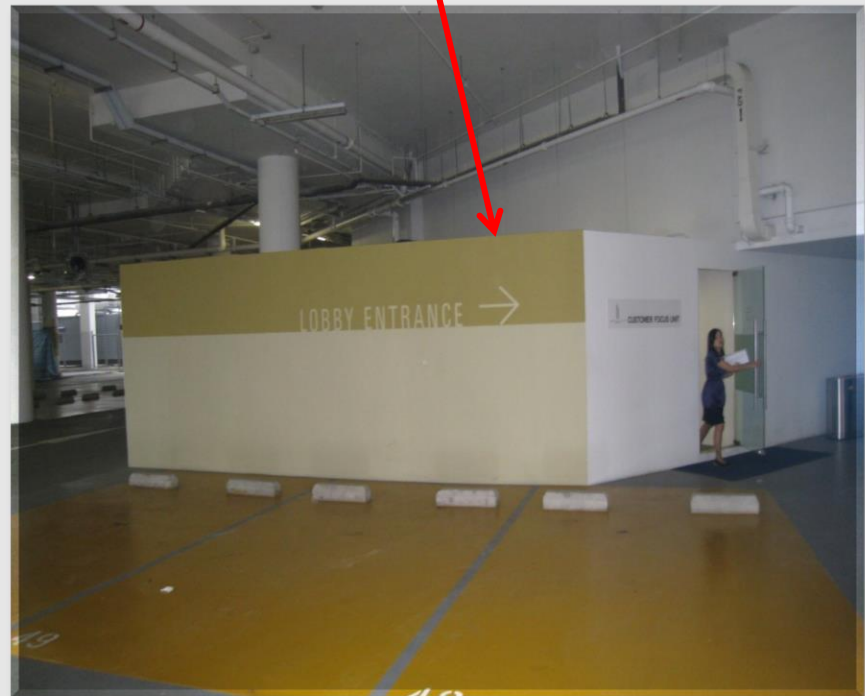
Unauthorised Change of Use  
/Structure at Car Park
