# Electrical Fires in Residential Premises (2008 – 2010)

The SCDF Fire Analysis Report series aim to make sense of similar fires seen over the years. Each report will provide details on the trends, patterns and other findings from the analysis of a specific type of fire or fire-related topic. Relevant examples of actual fire incidents will also be presented. In addition, fire safety tips or references to sources of information relating to fire prevention will be provided.

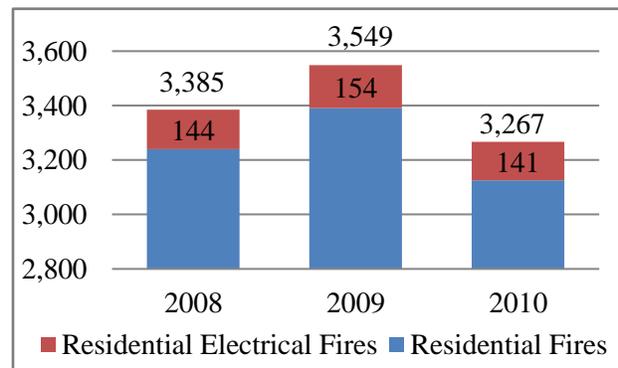
**Figure 1: Residential Electrical Fires (2008 – 2010)**

Electricity remains 1 of the top 3 causes of fires in Singapore residences. As shown in **Figure 1**, the number of fires, occurring in residential premises<sup>1</sup>, determined to be of electrical origin ranged from 141 to 154 for the 3-year period from 2008 to 2010. This works out to approximately 12 to 13 cases each month. On average, residential electrical fires constitute about 4.3% of all residential fires [1].

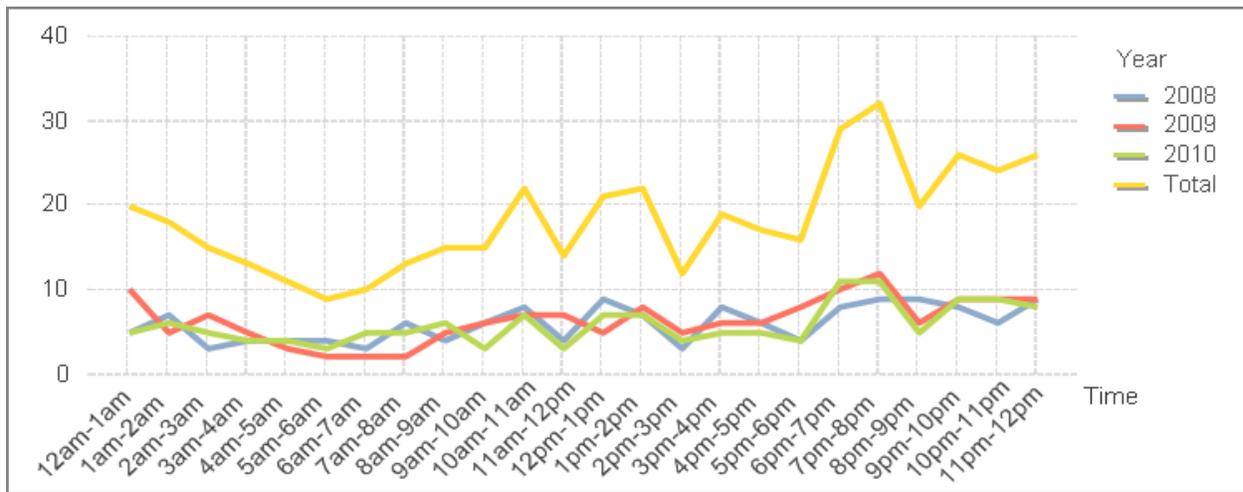
**Figure 2: Occurrence Time of Residential Electrical Fires (2008 – 2010)**

As seen in **Figure 2**, residential electrical fires are least likely to occur between 5 a.m. – 6 a.m. Thereafter, it increases gradually throughout the day up with the peak at 7 p.m. – 8 p.m. before gradually falling to the lowest point between 5 a.m. – 6 a.m. This general trend is also seen in the United States [2] where the lowest and highest points are similarly between 5 a.m. – 6 a.m. and 7 p.m. – 8 p.m. respectively.

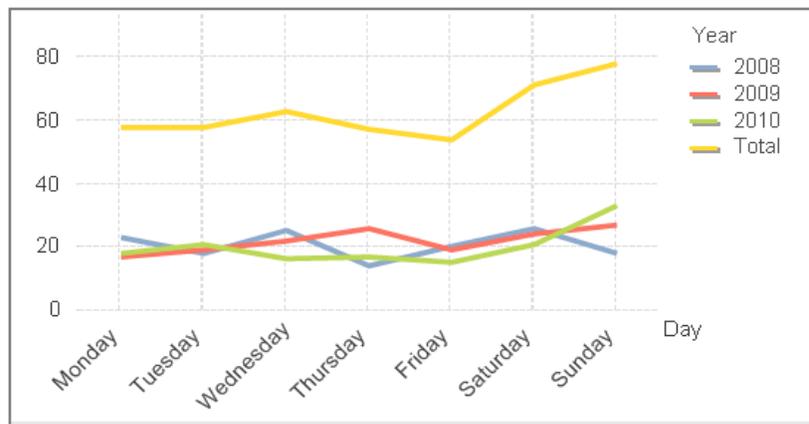
**Figure 3: Breakdown of Residential Electrical Fires by Day of the Week**

There appears to be higher numbers of residential electrical fires on Saturdays and particularly Sundays (see **Figure 3**).

As these are generally non-working days, there is a greater likelihood that residents would be at home and consuming more electricity (from the use of fans, air-conditioning, radio, television and other electrical appliances) than other days.

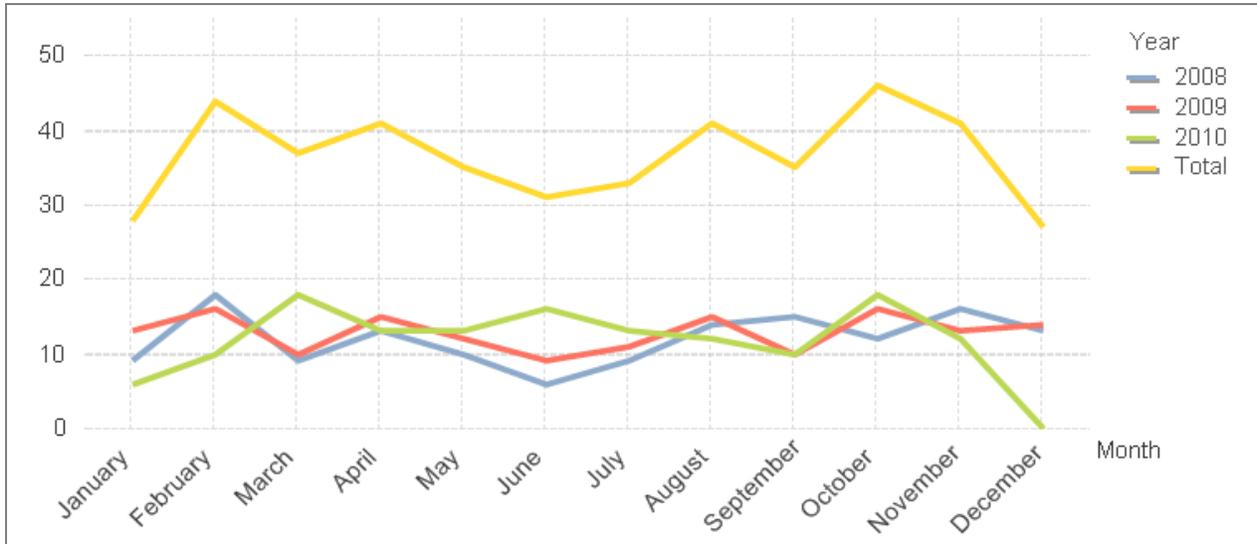
**Figure 4: Breakdown of Residential Electrical Fires by Month**

**Figure 4** shows a monthly breakdown of electrical fire incidents in residential premises. There are lesser electrical fires occurrences in the months of January, June and December while there are seemingly more cases in February, April, August and October.

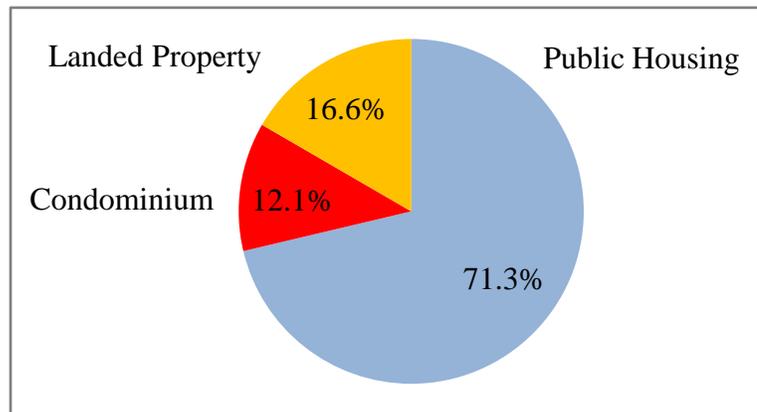
**Figure 5: Type of Residential Premises where Electrical Fires Occurred (2008 – 2010)**

Approximately 71.3% of residential electrical fires occurred in public residential premises. Condominiums and landed properties account for the remaining 12.1% and 16.6% respectively<sup>2</sup> (see **Figure 5**).

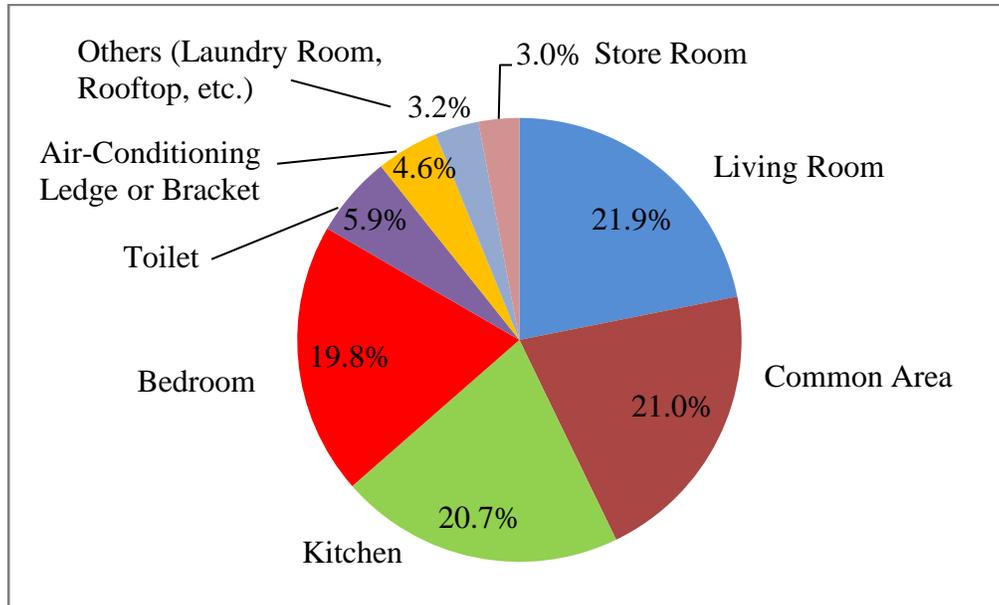
**Figure 6: Area of Fire Origin for Residential Electrical Fires (2008 – 2010)**

Within a residential unit<sup>3</sup>, the chances of an electrical fire occurring in the living room are the highest at 21.9% followed by the kitchen at 20.7%. The common areas, which refer to shared spaces such as the corridor, lift lobby and void deck, see 21.0% of all electrical fires in residential premises (see **Figure 6**).

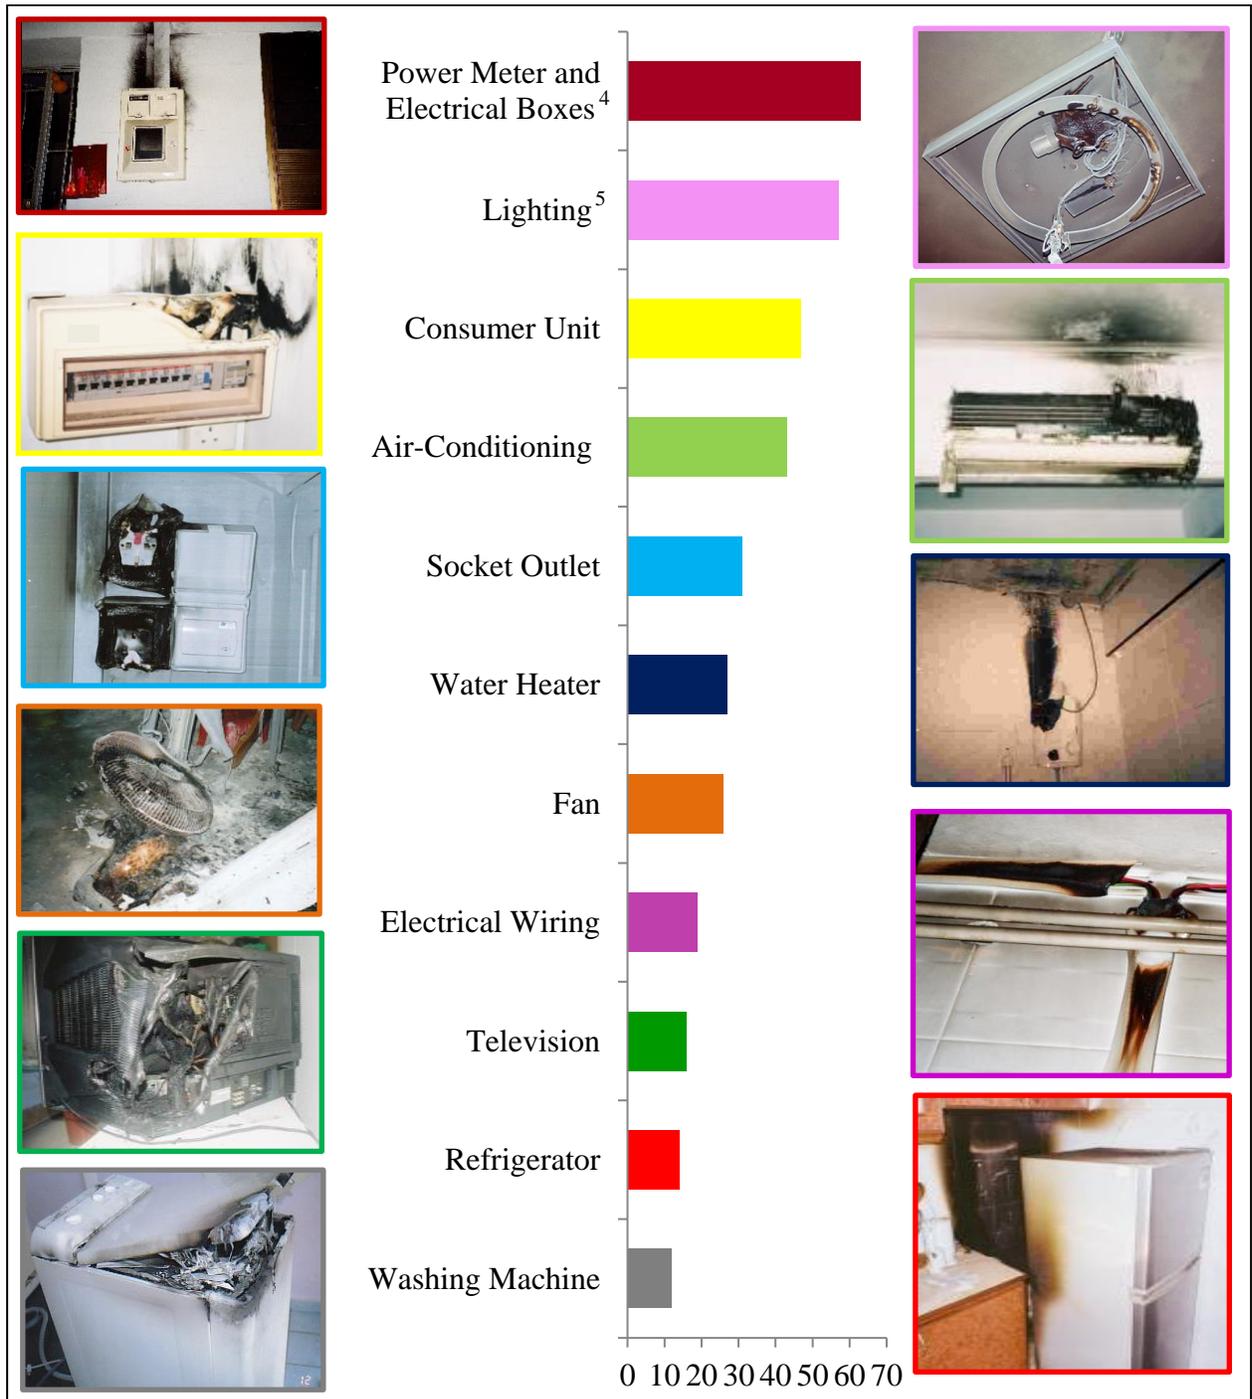
**Figure 7: Entities Commonly Involved in Residential Electrical Fires**

As shown in **Figure 7**, the most prevalent electrical fires in residential premises are those involving the power meter and electrical boxes outside the residential unit. The next most common entity involved is lighting which covers all forms of illumination within the residential unit and in the common areas.

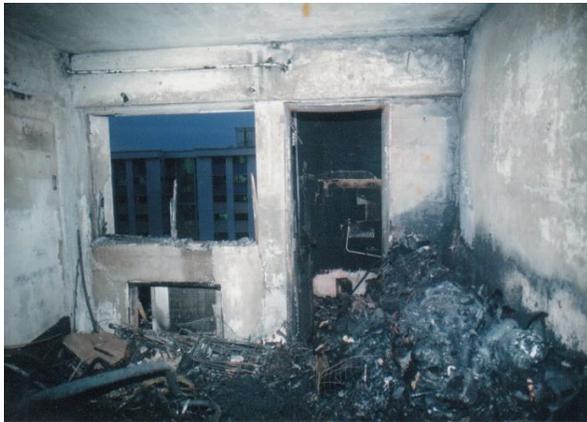
An 8-year-old girl was having a nap in the master bedroom, at the lower deck of a double-decker bed. Her father came to check on her and saw fire at the upper deck. He tried to put out the fire with a pail of water but was unsuccessful. The fire developed very quickly and they evacuated. The entire master bedroom was gutted by the fire (see **Figure 8**) while other parts of the unit sustained severe heat and smoke damage (see **Figure 9**). The burnt remains of a portable socket outlet, hi-fi set and electrical wirings were recovered in the Area of Fire Origin. The cause of fire was determined to be accidental and of electrical origin.

**Figure 8. The entire master bedroom was gutted by fire**

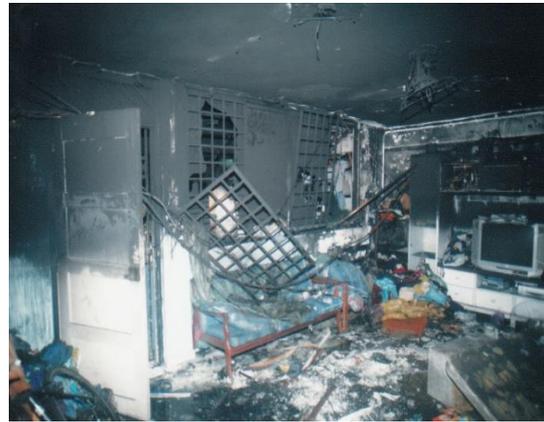
**Figure 9. Other parts of the unit sustained severe heat and smoke damage**

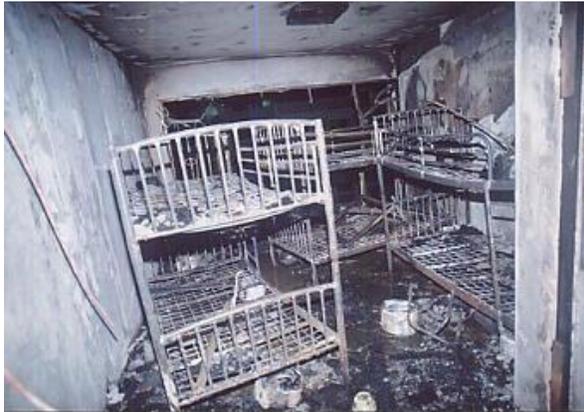
Mr Li was 1 of 6 occupants in the bedroom where the fire originated (see **Figure 10**). He had just returned home and he saw fire under a clothing rack when he entered his room. He shouted 'Fire!' to alert the other occupants of the unit and several of them tried to fight the fire but to no avail. The fire spread to the adjacent mattresses and developed rapidly. Mr Li sustained burn injuries when he tried to retrieve his luggage bag from underneath the burning bed. The fire consumed the wooden partition between the bedroom and the living room; and spread into the living room (see **Figure 11**).

**Figure 10. A section of the living room was partitioned up and used as a bedroom**

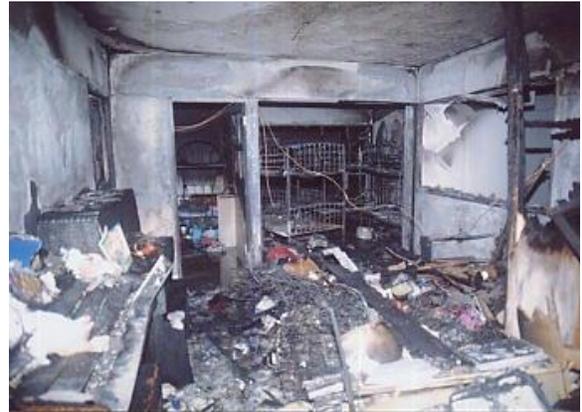
Mr Li explained that there was a portable socket outlet connected to a stand fan and microwave oven at the Area of Fire Origin. Both appliances were not in use at the time of the fire but the power to the portable socket outlet was always left 'ON'. The cause of fire was determined to be accidental and of electrical origin at the portable socket outlet.

**Figure 11. The fire consumed the wooden partition and spread into the living room**

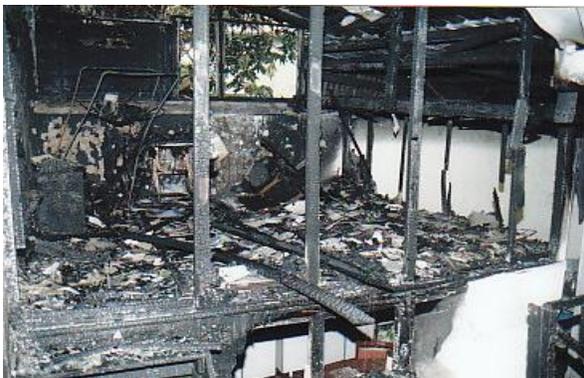
It was about 4 a.m. in the morning and all 4 members of this family were asleep in their respective bedrooms. They were all awoken by ‘popping’ sounds and the smell of something burning. 2 of them came out of their rooms and saw fire at the porch and roof. The family evacuated immediately and called SCDF for assistance. The fire developed and burned into the rooms (see **Figure 12**) and adjacent terrace house. The motorcycle and car (see **Figure 13**) at the porch were also damaged. The burn patterns indicated that the Area of Fire Origin was at the porch where a consumer unit was mounted. There were no indications of other possible accidental fire causes and there were no indicators of incendiarism. The cause of fire was established to be accidental and of electrical origin at the consumer unit.

**Figure 12. Fire developed and burned into the rooms**

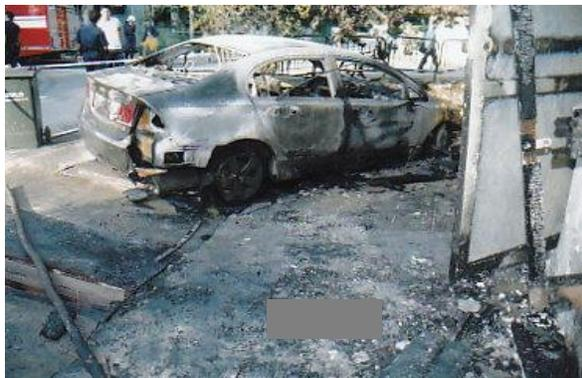
**Figure 13. The motorcycle and car at the porch area were also damaged**

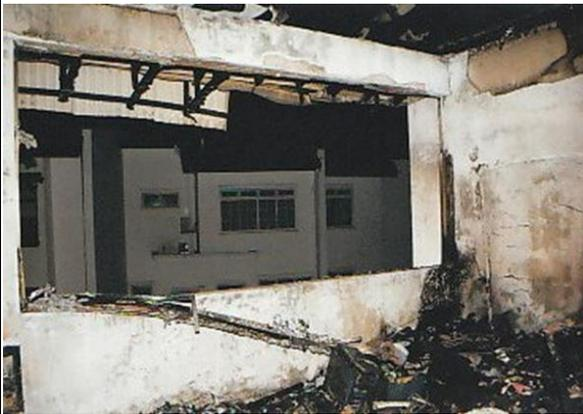
The occupant experienced a power trip when he switched on all the electrical appliances after returning home. Upon resetting the consumer unit, he went about with his routine but noticed smoke at the second level of the 3-storey terrace house shortly thereafter. Fire damage was severe in the master bedroom (see **Figure 14**) while other parts of the house sustained heat, smoke and water damage. The burn patterns were consistent with that of a fire which originated from a location near the windows, where a computer table used to be. The burned remains of a portable socket outlet was recovered from the determined Area of Fire Origin (see **Figure 15**). According to the occupant, this portable socket outlet was brought over from overseas. The cause of fire was determined to be accidental and of electrical origin at the portable socket outlet.

**Figure 14. Fire damage was severe in the master bedroom**

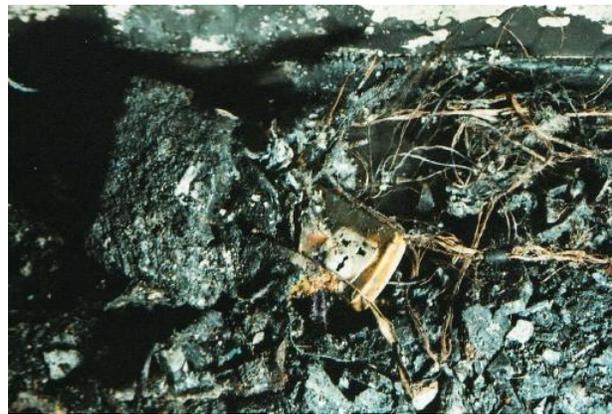
**Figure 15. The burned remains of a portable socket outlet**

One of the fundamental conditions for ignition by an electrical source is that the conductor has to be energised. Hence, always switch off appliances at the wall socket when they are not in use. Switching ‘OFF’ at the wall socket effectively cuts off the flow of current from the wall socket to the appliance. Without electricity, ignition at any point along the circuit from plug to appliance is impossible.
