Fires Involving Air Conditioning Fan Coil Units (2008 – 2014)

The SCDF Fire Analysis Report series aim to make sense of similar fires seen over the years. Each report will provide details on the trends, patterns and other findings from the analysis of a specific type of fire or fire-related topic. Relevant examples of actual fire incidents will also be presented. In addition, fire safety tips or references to sources of information relating to fire prevention will be provided.

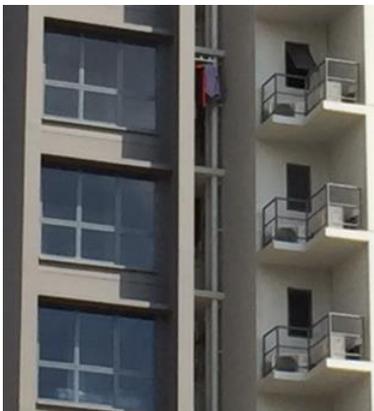
Figure 2. Condensing Units on A/C ledges

The typical A/C used in Singapore homes is the multi-split system which comprises a Condensing Unit (also known as the outdoor unit) and a number of wall-mounted Fan Coil Units (also called the indoor units). The Condensing Unit (CU) sits on a purpose-built A/C ledge (see **Figure 2**) or on brackets (see **Figure 3**) which protrudes out at the exterior of the building. The isolator of the A/C system is usually installed near the CU within the apartment or on an exterior building wall near the CU, which should be within reach from a window. The Fan Coil Unit (FCU), on the other hand, is usually mounted high on 1 of the walls of the rooms which require air conditioning as shown in **Figure 4**.

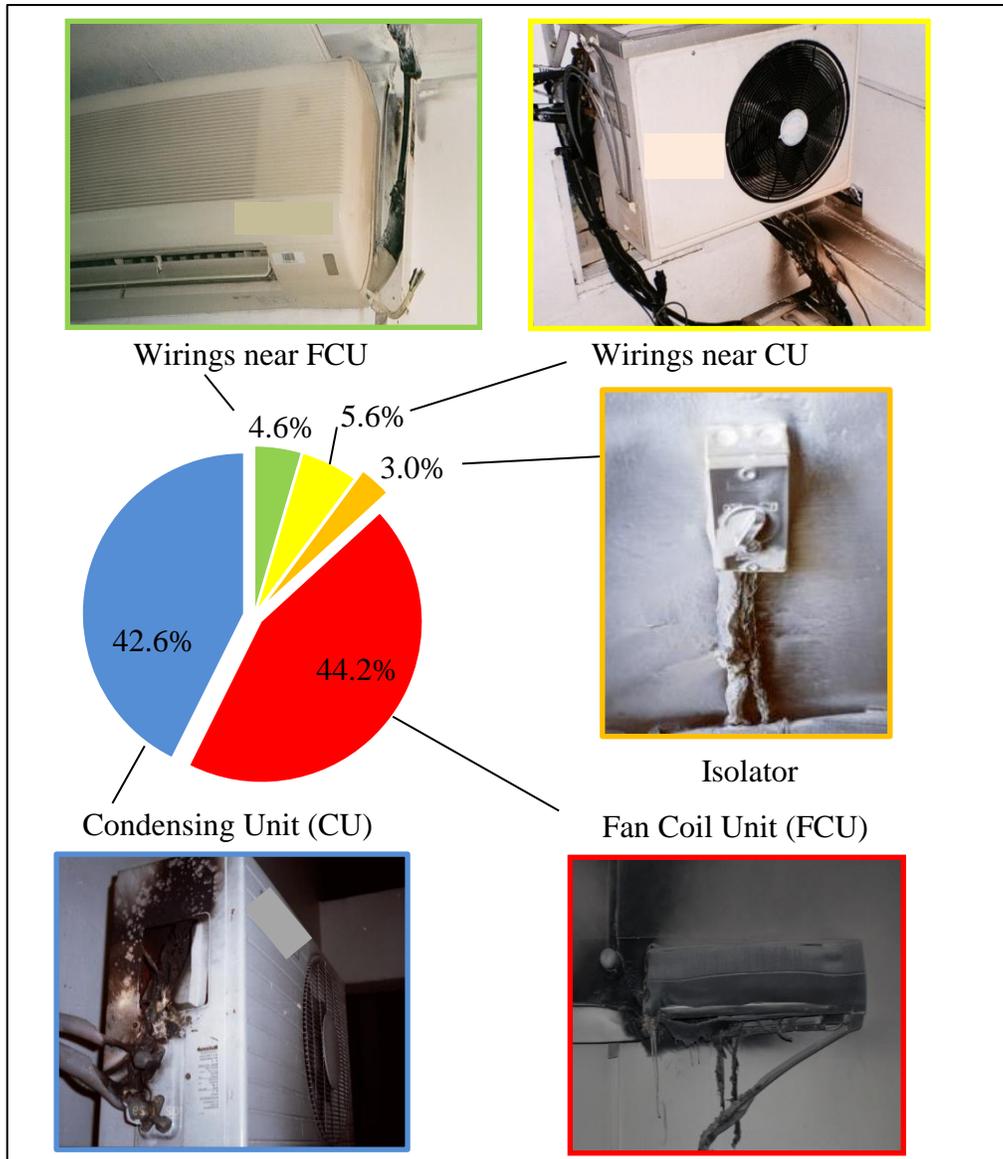
Figure 5. Breakdown of A/C Fires (2008 – 2014)

Various parts of the A/C system can catch fire as shown in **Figure 5**. For all the A/C system fires registered during the 7-year period from 2008 – 2014, 5.6% were noted to involve wirings near the CU while 4.6% involved wirings near the FCU. Fires involving the isolator accounted for 3.0%.

The detailed breakdown of the specific number of cases can be found in **Table 1**. Evident from the photographs in both **Figure 5** and **Table 1**, all the wirings and isolator fires were localised with most of them burning themselves out without any human intervention.

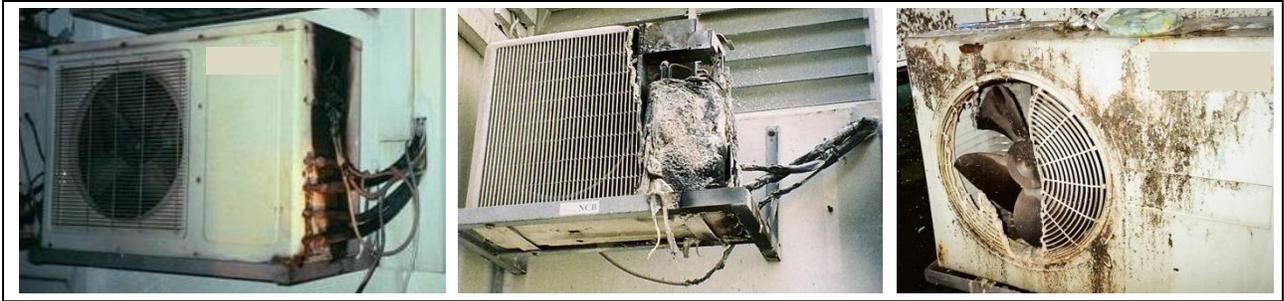
Figure 6. Fires involving the CUs

There were significantly more fires involving the CU and the FCU. From 2008 – 2014, fires involving the CU accounted for 42.6% of all A/C system fires. CU fires were observed to be largely localised (see **Figure 6**) with no potential of extensive fire spread as the CUs are located outdoors, with no other combustibles nearby. FCU fires, on the other hand, account for 44.2% of all A/C system fires from 2008 – 2014. As illustrated in **Figure 7**, FCU fires can possibly result in substantial property damage.

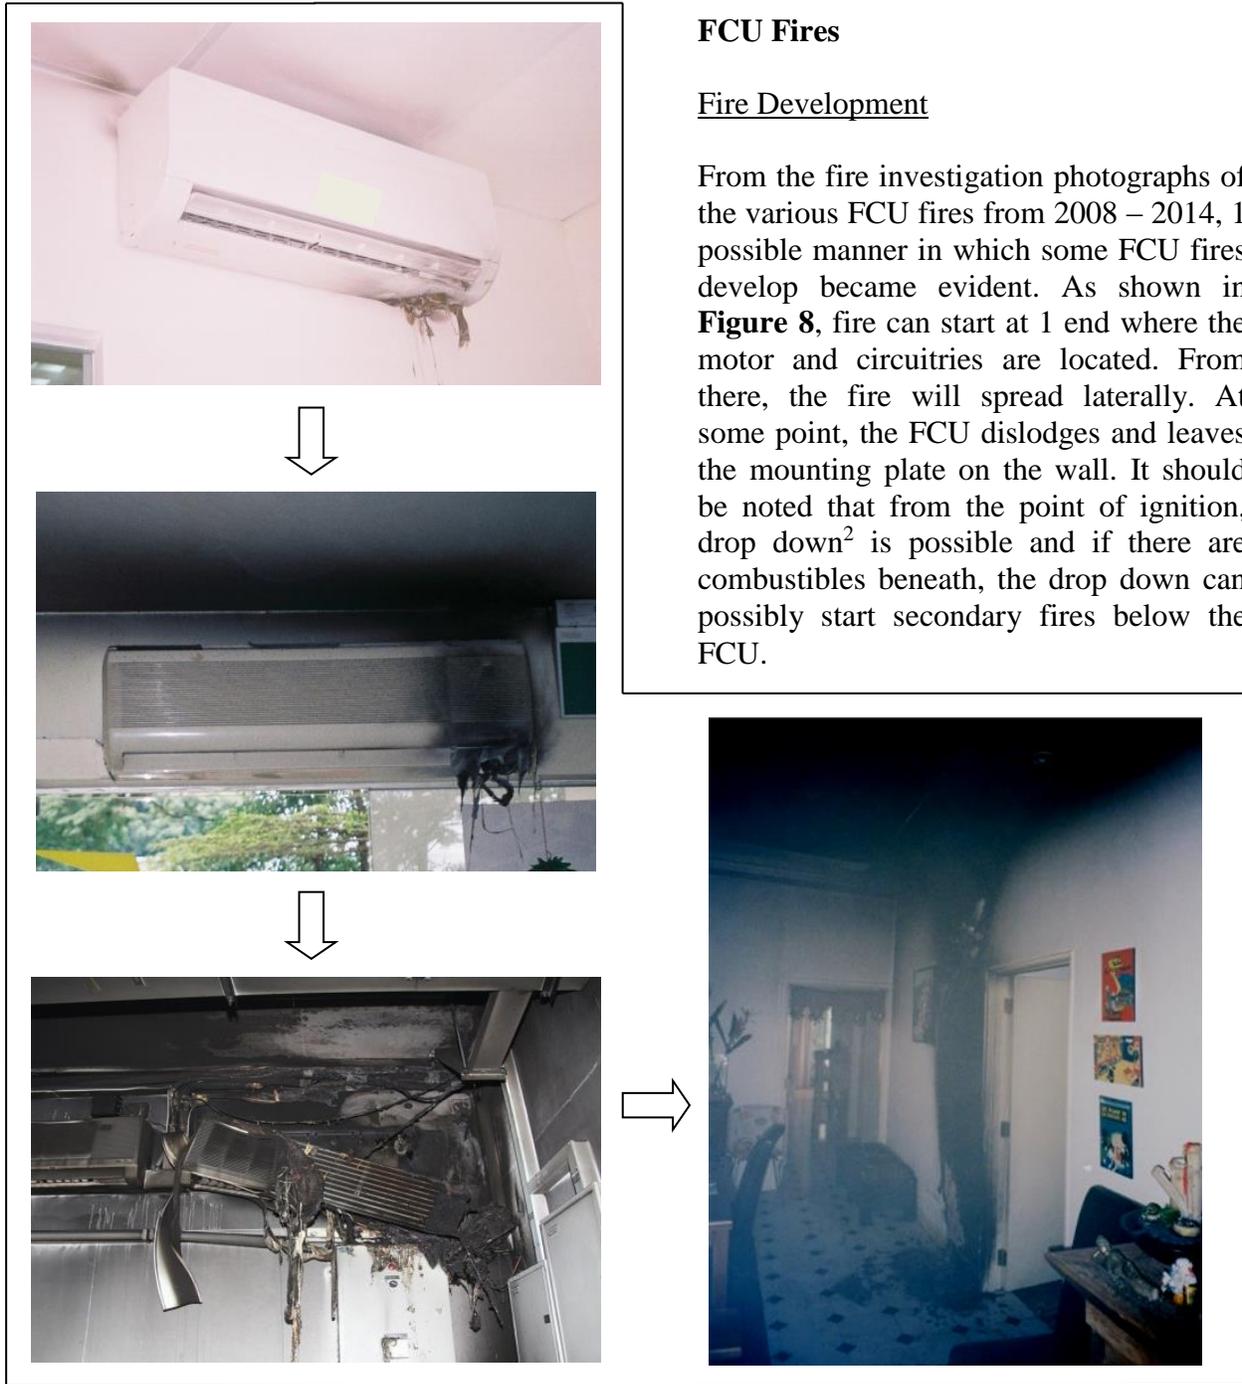
Figure 8. Development of FCU Fires

From the fire investigation photographs of the various FCU fires from 2008 – 2014, 1 possible manner in which some FCU fires develop became evident. As shown in **Figure 8**, fire can start at 1 end where the motor and circuitries are located. From there, the fire will spread laterally. At some point, the FCU dislodges and leaves the mounting plate on the wall. It should be noted that from the point of ignition, drop down² is possible and if there are combustibles beneath, the drop down can possibly start secondary fires below the FCU.

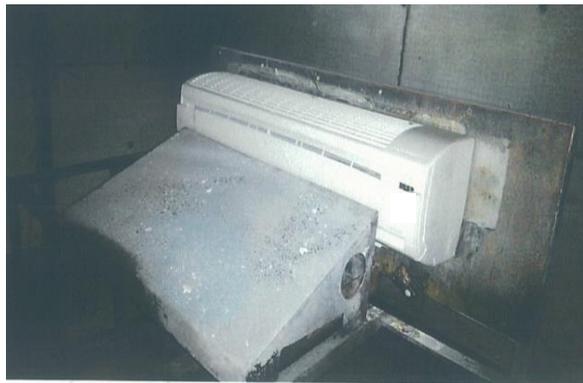
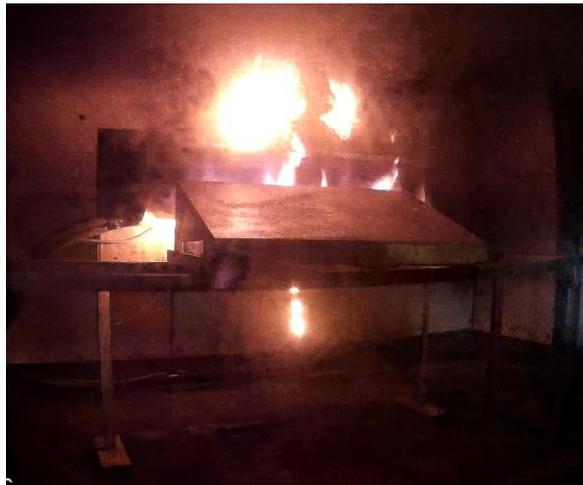
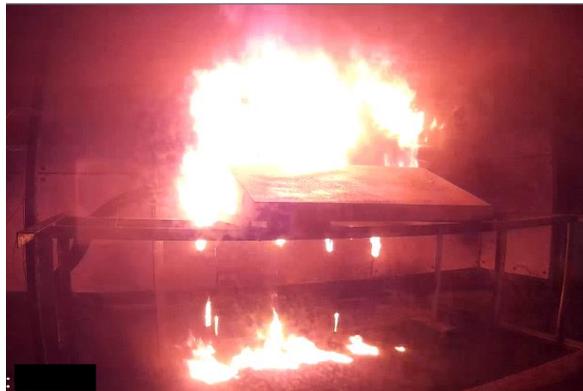
Figure 9. FCU burn test set-up and the drop down effects observed

(a) FCU burn test set-up

(b) 'Dripping fire' observed

(c) Pool fire formed below the FCU

Burn tests conducted on FCUs (see **Figure 9**) show that the plastic cover of the FCU would melt and result in 'dripping fires'. The pool fire formed below the FCU is evidently a competent ignition source that can start a secondary fire involving combustibles placed under the FCU.

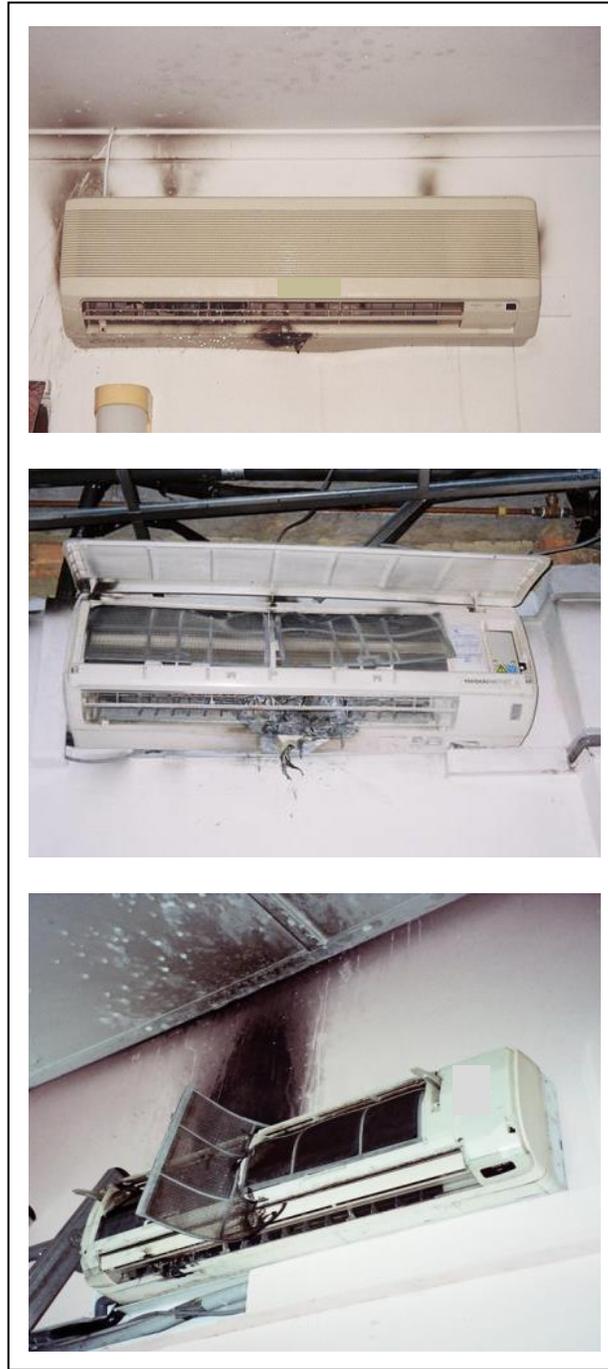
Figure 11. Fires originating from the mid-section of the FCU

Another location where FCU fires can start was observed to be behind the louvers, near the mid-section of the FCU as shown in **Figure 11**. Away from the motor and circuitries, the only possible ignition source for such fires is from the electrical cables that run across the length of the FCU. Such a fire will be examined in greater detail in 1 of the subsequent sections (Be Warned!) of this report.

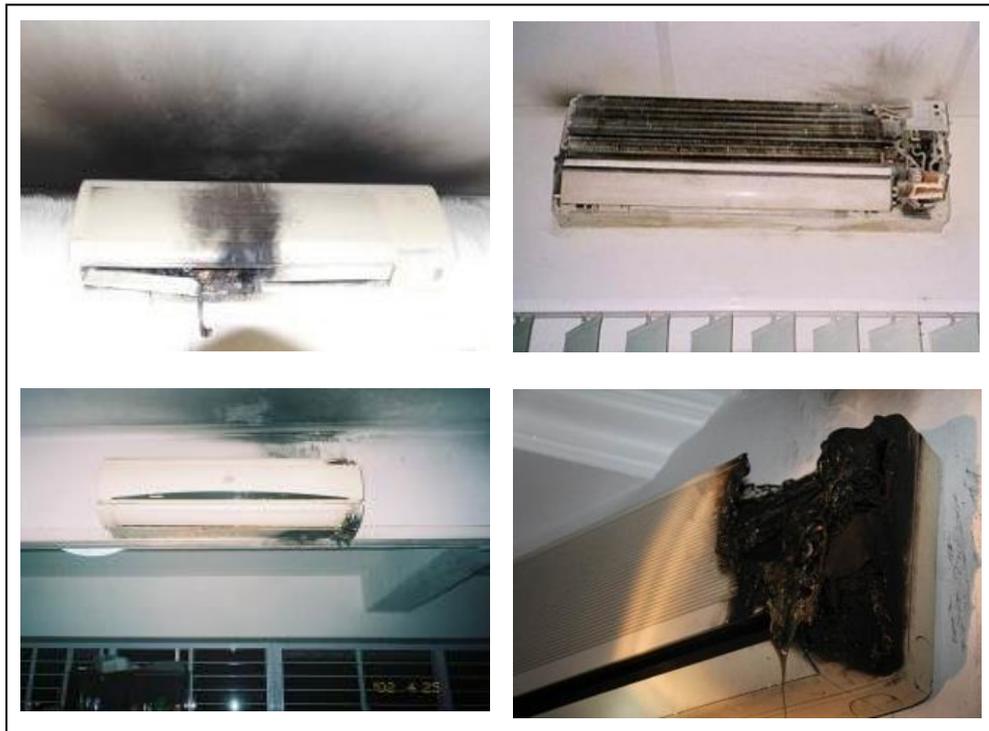
Figure 13. Localised fires involving FCUs which were on standby mode

As stated in the NFPA921: Guide for Fire and Explosion Investigations, for ignition to be from an electrical source, the electrical wiring, equipment or component must have been energised [5]. Unless the isolator near the CU is switched off, current will still be flowing in the wirings to the FCU. While this current that is going to the FCU on standby mode is low, at 0.01A for some brands, it should be noted that ignition is still possible. As shown in **Figure 12**, 26.4% of all FCU fires from 2008 – 2014 were involving FCUs that were not operating but on standby mode. **Figure 13** shows 4 localised fires involving the FCU on standby mode. A clear sign that these FCUs were on standby mode is that the louvers were all closed.

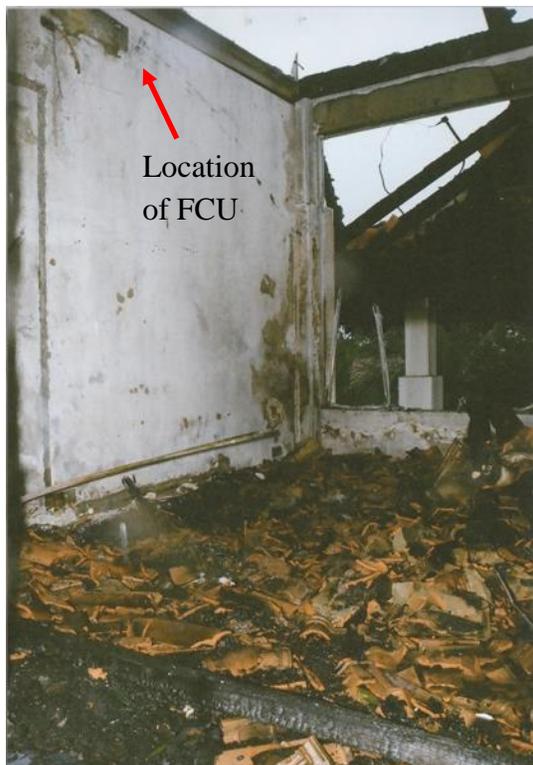
Figure 14. The FCU caught fire and the drop down ignited the bed directly beneath

A 10-year-old girl was sleeping on her bed at the upper floor of a 2-storey house when she saw the FCU above her bed catching fire. She got out just before the FCU fell onto her bed and ran to inform her mother next door. When she returned with her mother, the bed already was well alight and they evacuated from the house with the rest of the family members. As a result of the fire, the entire level 2, including the roof, was damaged (see **Figure 14** and **15**).

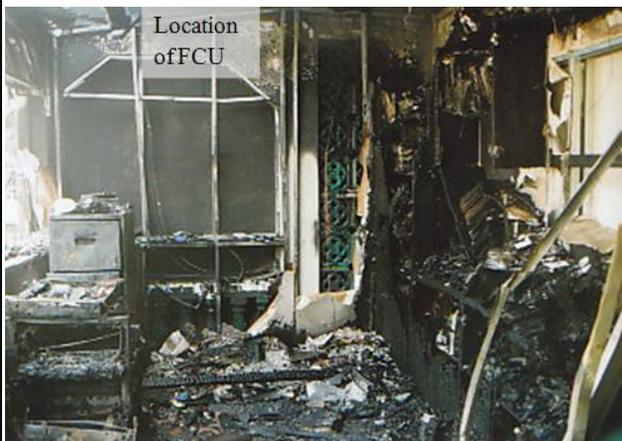
Figure 16. The initial firefighting efforts was unsuccessful and the FCU fire spread to other parts of the office

As a result of the fire, the contents of the office were damaged (see **Figure 16**) while other parts of the building sustained heat, smoke and water damage (see **Figure 17**).

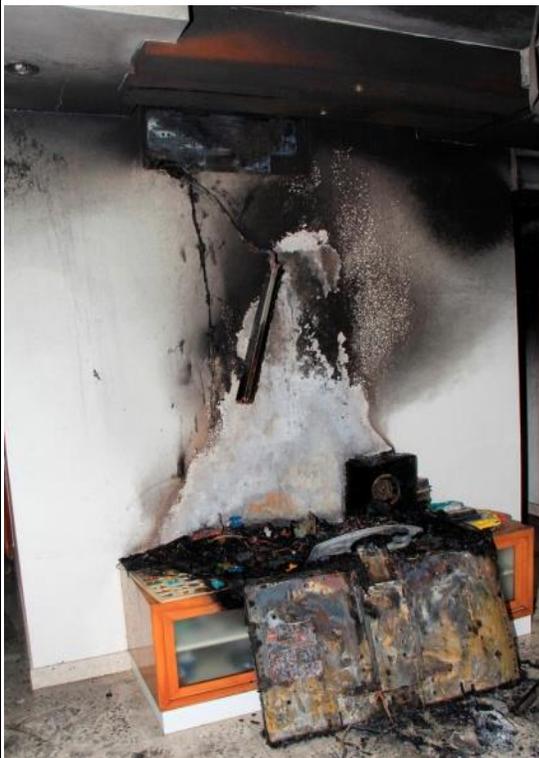
Figure 18. Drop down from the FCU fire damaged the TV and other items beneath

A project manager was holding a meeting in the same building when he received a call from his colleague informing him of black smoke bellowing from an apartment on 1 of the higher floors. He and 3 of his colleagues then rushed up to the affected apartment to investigate and on seeing the fire, they used a hose reel to extinguish it. Drop down from the FCU fire ignited the TV and other items on the TV console (see **Figure 18**). The apartment sustained heat and smoke damage as a result of the ceiling jet³ and ceiling layer⁴ from the FCU fire (see **Figure 19**).

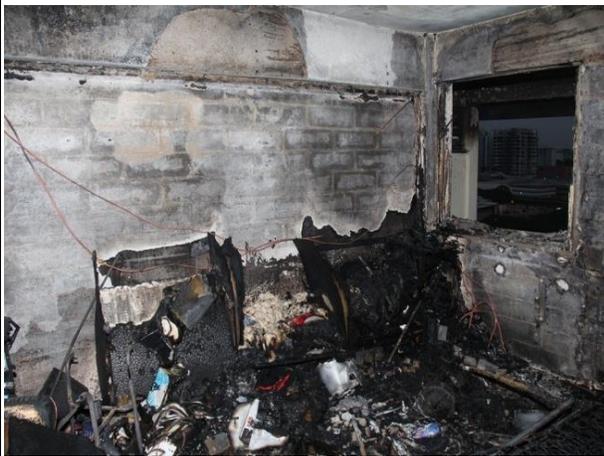
Figure 20. Fire damage was severe in the bedroom

It was 4.45 a.m. and Mdm Chin was just sleeping when she was awakened by bright sparks from the FCU in her bedroom. She then switched off the FCU and proceeded to retrieve a standing fan from the living room. In the midst of retrieving the standing fan, she observed white smoke emerging from her bedroom. She scurried back to her bedroom and saw the FCU on fire. She called SCDF for assistance immediately and evacuated from her residential unit. Fire damage was severe in the bedroom (see **Figure 20**) while other parts of the residential unit sustained heat and smoke damage (see **Figure 21**).

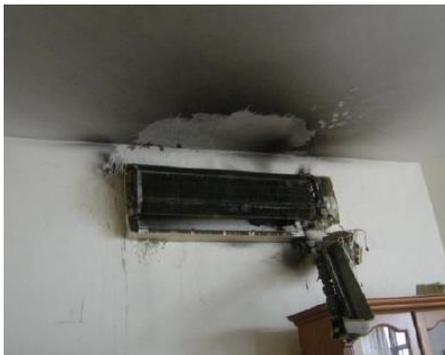
Figure 22. A localised FCU fire

Figure 22 shows a localised FCU fire. A close examination of the motor and circuitries (see **Figure 23** and **Figure 24**) show that both were completely unaffected and hence, ruled out as the cause of fire. The burnt area on the FCU is captured in **Figure 25** with the electrical cable that was running across the FCU being held in place.

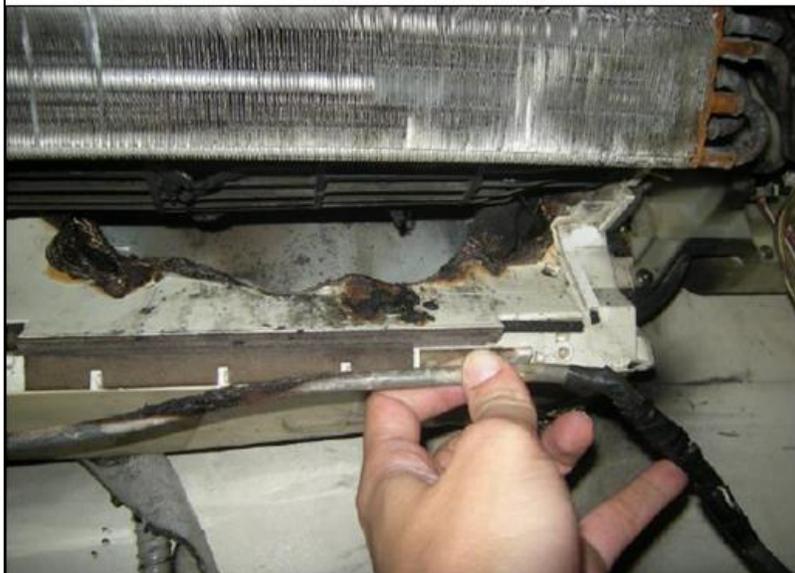
Figure 25. The burnt area on the FCU with the electrical cable that was running across

The burnt section on the left side of the cable was damaged as a result of the fire as the bulk of the insulation is still intact. Had this section been the cause of fire, the insulation would have been consumed by the fire inside out.

The burnt section on the right is an intermediate connection achieved by twisting wires together and insulating them with electrical tape. A zoomed-in image of this intermediate connection can be found in **Figure 26**. From **Figure 26**, one would be able to see mass loss to the electrical tape, with the internal wiring exposed. All the above investigation findings are consistent with the ignition source of the fire to have come about from this point on the intermediate connection.

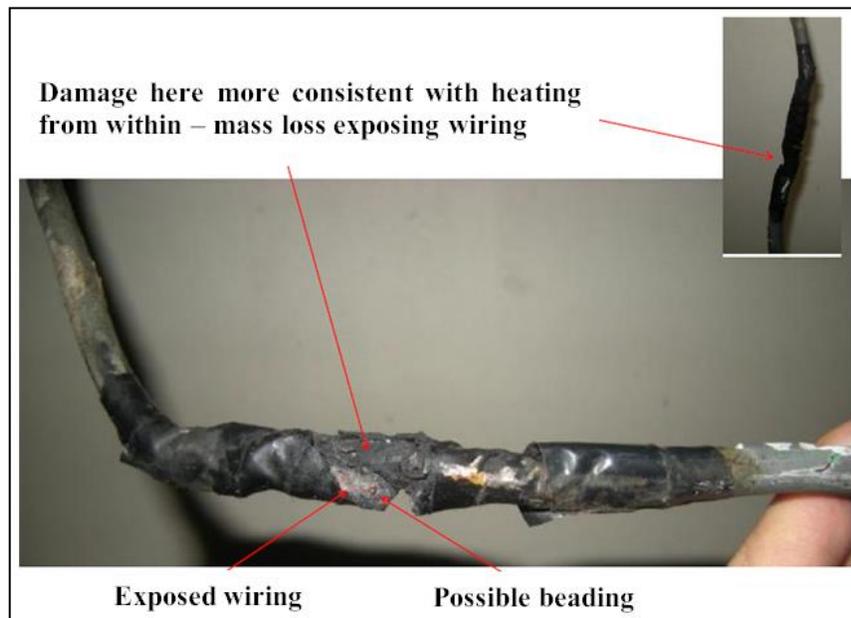
Figure 26. A zoomed-in image of the intermediate connection

One prominent root cause of FCU fires seen in Singapore is the use of intermediate connections, by means of twisting wires together and insulating them with electrical tape, within the FCU. Such a technique for creating an electrical splice is widely practised in Singapore but can be problematic especially when it is applied in FCUs.

Proper installation of the A/C system is the critical first step in the prevention of FCU fires. For people living in HDB flats, there are guidelines for A/C installation works and these are available at the HDB website [13].

Described as ‘a flagrant violation of both regulation [16] and good sense’ in the Ignition Handbook [17], electrical splices achieved by twisting wires together and insulating them with electrical tape are not allowed in the United States as they have been found to be the cause of many fires in the earlier days. The use of such splices in FCUs may greatly heighten fire risk as water from condensation can come into the picture.
