# Refuse Chute Fires in Public Housing Estates (2011 – 2013)

The SCDF Fire Analysis Report series aim to make sense of similar fires seen over the years. Each report will provide details on the trends, patterns and other findings from the analysis of a specific type of fire or fire-related topic. Relevant examples of actual fire incidents will also be presented. In addition, fire safety tips or references to sources of information relating to fire prevention will be provided.

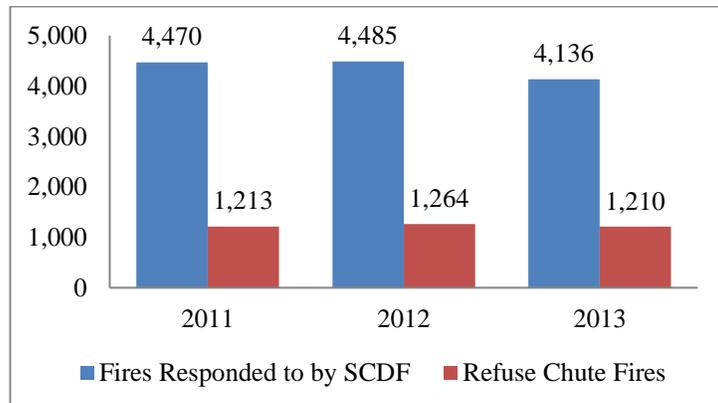
Refuse chute fires constitute about 28.2% of all reported fires in Singapore as shown in Figure 1. The number of refuse chute fires ranged from 1,210 to 1,264 for the 3-year period from 2011 to 2013 which works out to a monthly average of 102 cases [1,2,3].

**Figure 1. Refuse chute fires (2011 – 2013)**

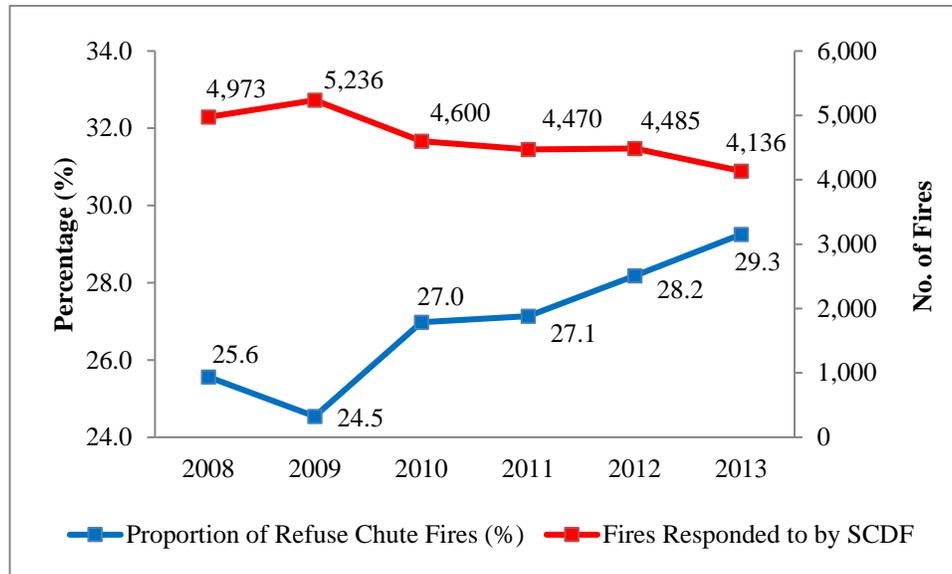
As seen in **Figure 2**, the proportion of refuse chutes fires<sup>1</sup> is noted to be on the rise throughout the 3-year period.

**Figure 2. Proportion of refuse chute fires (2008 – 2013)**

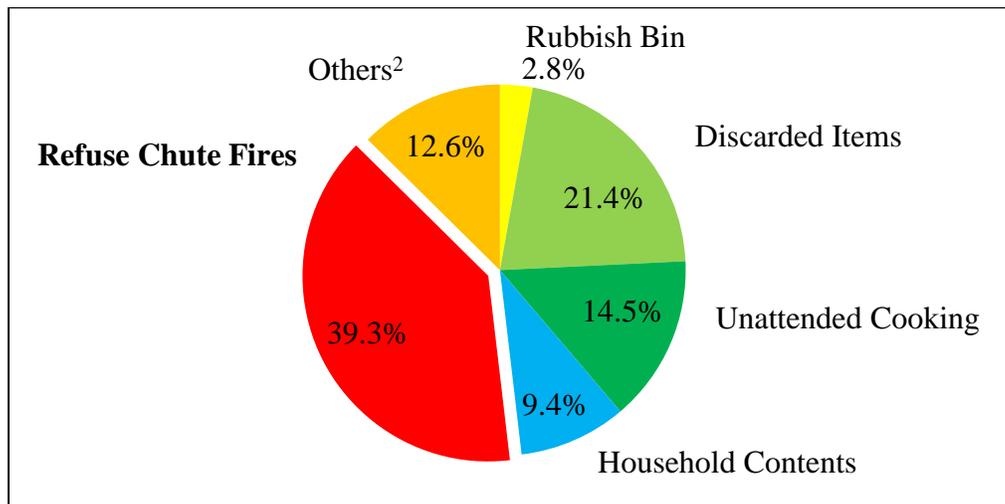
Refuse chute fires make up the bulk of the fires seen in residential premises from 2011 – 2013. This is followed by fires involving discarded items and fire involving unattended cooking as seen in **Figure 3**.

**Figure 3. Breakdown of residential fires (2011 – 2013)**

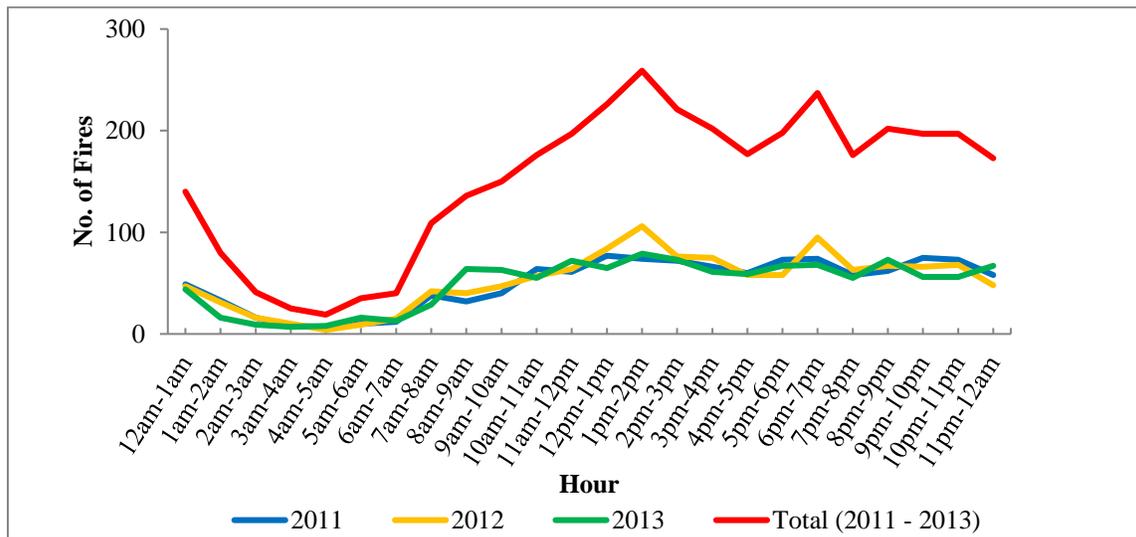
As seen in **Figure 5**, the number of refuse chute fires is generally low in the early morning between 3 am and 7 am. After 7 am, the number of incidents rises sharply and peaks between 1 pm to 2 pm. Thereafter, it decreases gradually, with another localised peak at 6 pm to 7 pm. From 11 pm onwards, the number of refuse chute fires would start to decline. This overall trend in the hourly breakdown of refuse chute fires (2011 – 2013) is noted to be similar to that seen in the preceding 3-year period between 2008 – 2010 [4].

**Figure 5. Occurrence time of refuse chute fires (2011 – 2013)**

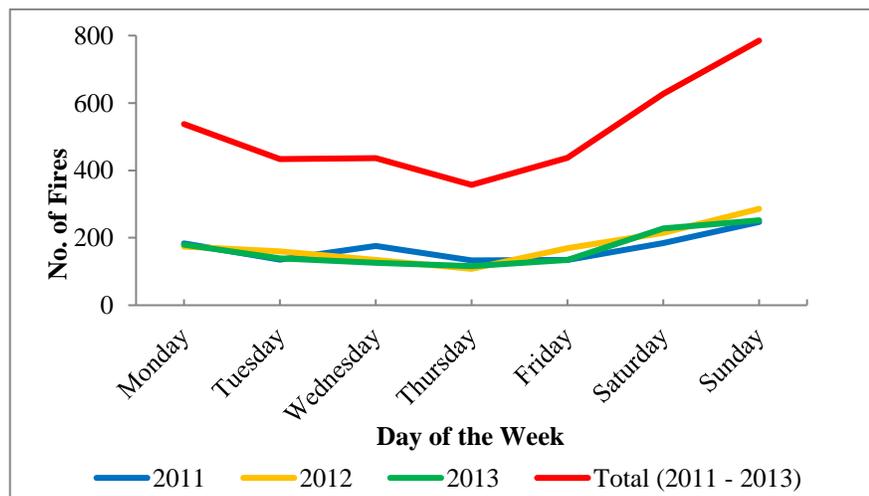
**Figure 6** shows that refuse chute fires are typically lowest near mid-week. From there, the number of refuse chute fires rises to peak on Sunday. Thereafter, refuse chute fires will dip to the lowest point in the mid-week. Such a trend was also observed in the preceding 3-year period from 2008 – 2010 [4].

**Figure 6. Refuse chute fires by day of the week (2011 – 2013)**

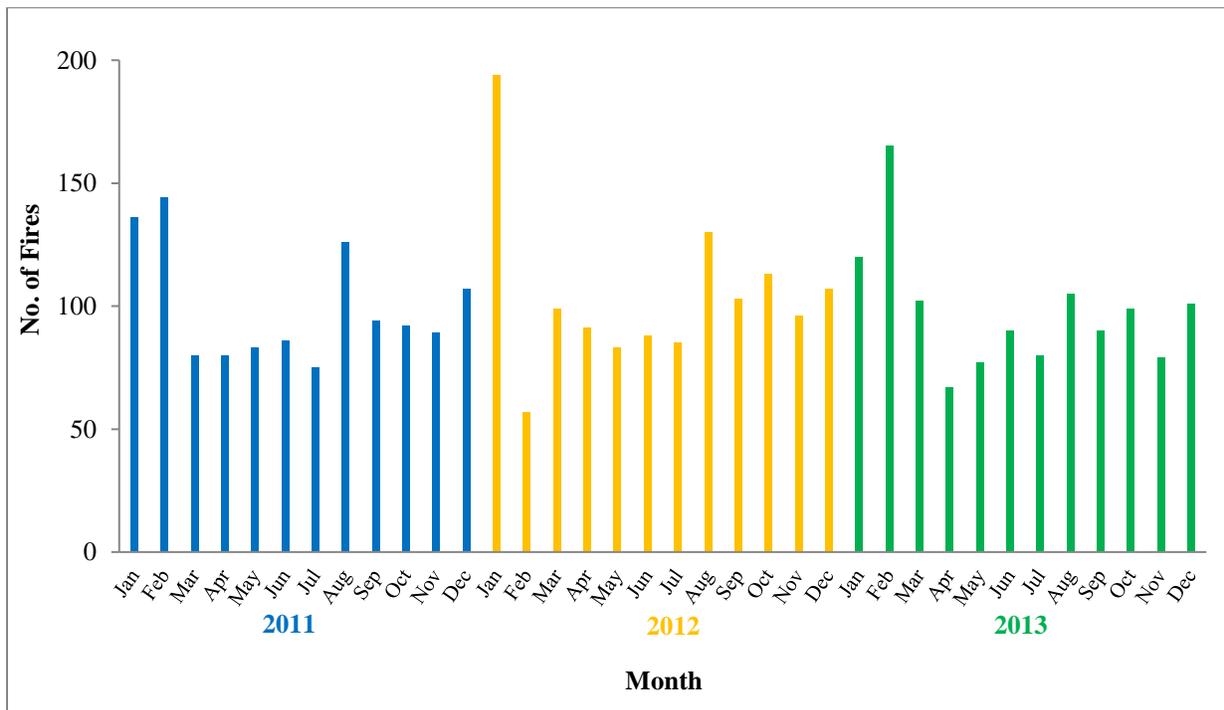
The first day of the CNY falls on 3 February, 23 January and 10 February for 2011, 2012 and 2013 respectively [5,6,7]. Accordingly, February 2011, January 2012 and February 2013 were the months which saw exceedingly high numbers of refuse chute fire as evident in **Figure 7**.

**Figure 7. Refuse chute fires of the months (2011 – 2013)**

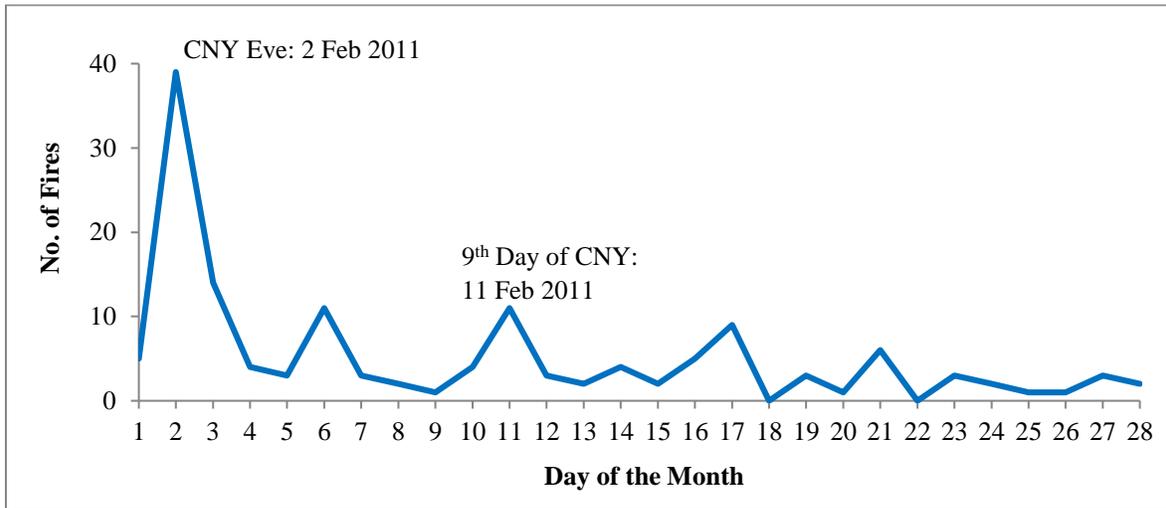
A breakdown by day of the 3 CNY months revealed that most of the fires occurred on the eves of CNY as seen in **Figure 8, 9** and **10**. A recurring smaller peak is also always observed on the 9<sup>th</sup> day of CNY which coincides with the occasion where the Chinese traditionally pray.

**Figure 8. Refuse chute fires for the CNY month of February 2011**

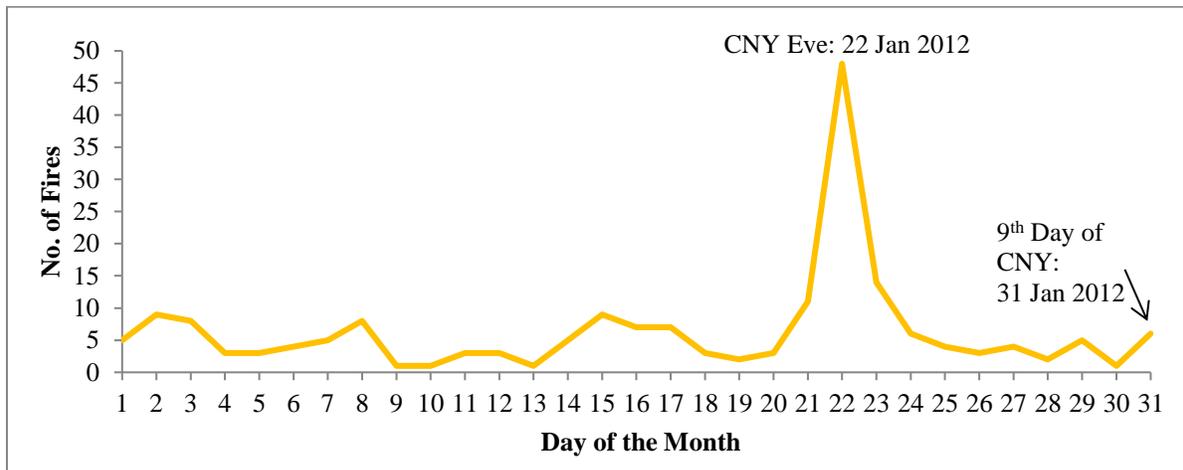
**Figure 9. Refuse chute fires for the CNY month of January 2012**

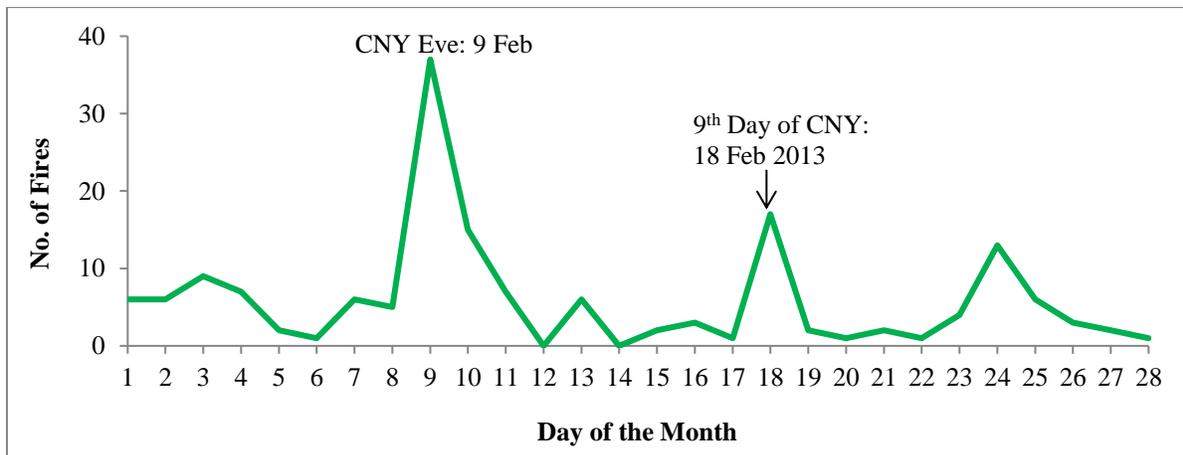
**Figure 10. Refuse chute fires for the CNY month of February 2013**

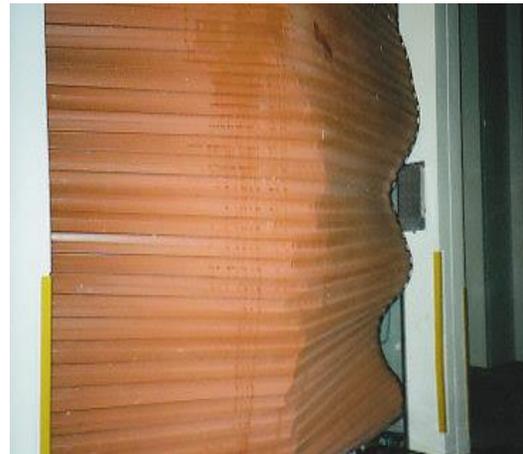
It was close to midnight when SCDF received an emergency call from a resident reporting a refuse chute on fire. When SCDF responders arrived, blast effects have damaged the roller shutter of the bin centre (see **Figure 11**). On further investigation, it appeared that the blast occurred from within the Refuse Handling Equipment (RHE) as its contents were emptied out (see **Figure 12**).

**Figure 11. Blast effects were observed**

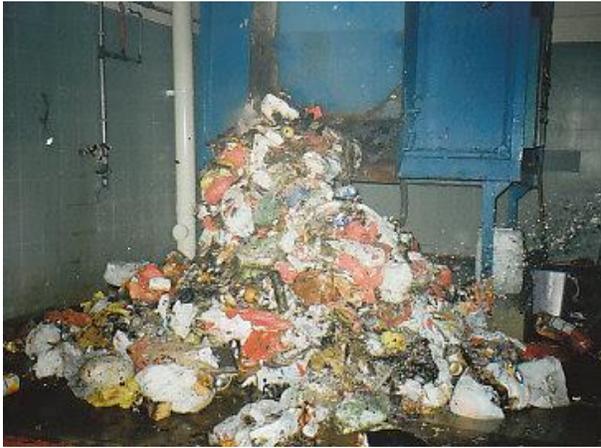
**Figure 12. Refuse in the RHE were emptied out**

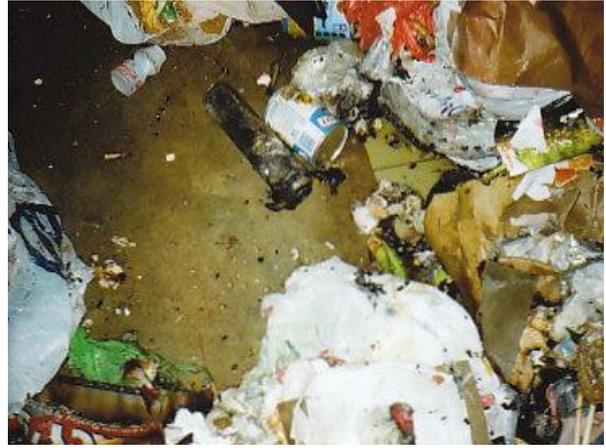
A ruptured aerosol can with burn marks was recovered amongst the refuse as shown in **Figure 13**. The blast effects were likely to have come about as a result of the rupturing of the aerosol can. It is fortunate that the incident happened late at night when there were no workers in the bin centre.

**Figure 13. A ruptured aerosol can recovered amongst the refuse**

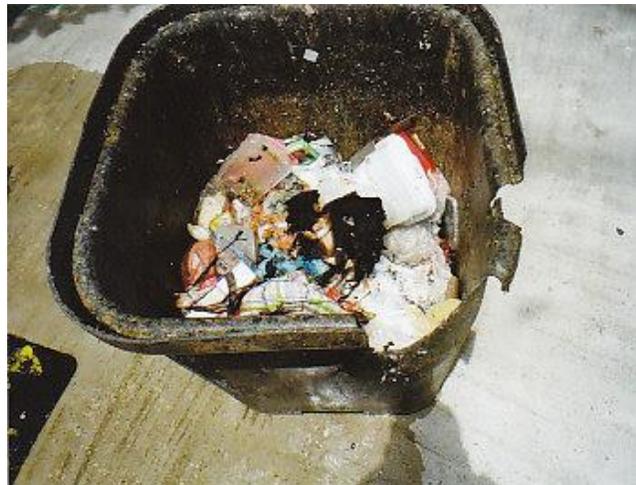
SCDF responders were dispatched to a refuse chute on fire on a Sunday afternoon. On arrival, one of the Individual Refuse Collection System (IRCS) chutes has caught fire and they extinguished the fire with buckets of water. The refuse bin inside the chute sustained heat damage. On sieving through, a burned rag was found as seen in **Figure 14**. The cause of fire was determined to be incendiary<sup>4</sup>.

**Figure 14. A burned rag was found inside the bin amongst other refuse**

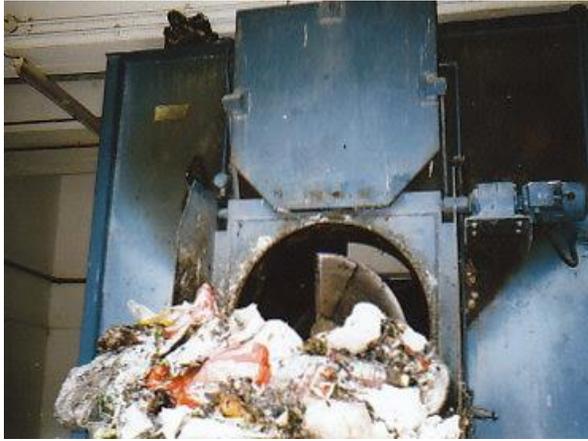
She immediately called SCDF for assistance. The fire was contained within the RHE. As a result of the fire, the RHE sustained heat damage and burned paint tins were recovered amongst the refuse (see **Figure 15** and **16**).

**Figure 15. The RHE sustained heat damage**

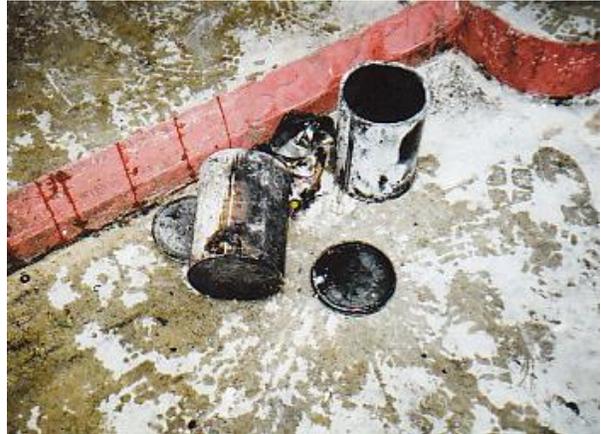
**Figure 16. Burned paint tins were recovered amongst the refuse**

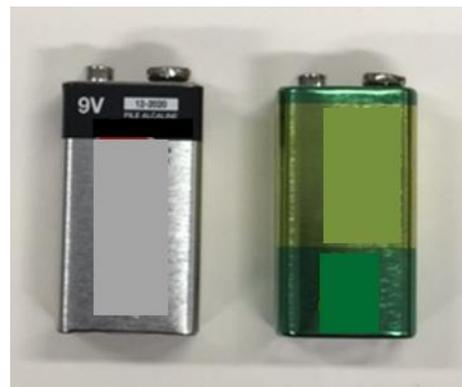
Besides the common causes of refuse chute fires due to the indiscriminate disposal of lighted materials and act of mischief [4], another potential cause could be one of electrical origin – short circuiting of discarded batteries. Batteries are commonly used to power household items such as clocks and toys. One of the battery types commonly found in households is the 9-volt battery (see **Figure 17**). It has positive and negative terminal close together. If a metal object touches both terminals, it can cause a short circuit. This can generate sufficient heat to cause a fire. Fires involving refuse have happened due to the disposal of 9-volt batteries together with other metal items [13]. SCDF has also responded to similar fire incidents where discarded batteries were consolidated within metal containers as seen in **Figure 18**.

**Figure 17. 9-volt batteries**

Covering the terminal of batteries using masking tape or electrical tape before disposal may prevent short circuiting which may lead to fires [13]. The public is also urged to be more fire safety conscious and refrain from disposing lighted materials down the refuse chute. For instance, lighted cigarettes must be extinguished fully and charcoal embers must be doused with water before disposal.

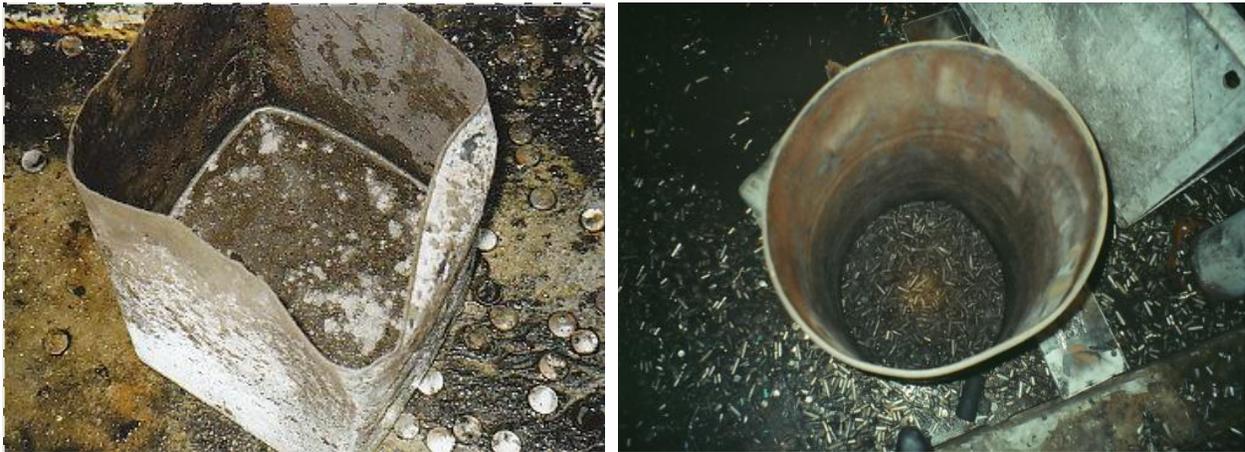
**Figure 18. Discarded batteries of various sizes stored in metal containers were involved in fires**
